# Modes of Strand Damage Observed by Magneto-Optical Imaging and Metallography

A. A. Polyanskii, P. J. Lee,  
M. C. Jewell, D. C. Larbalestier

- Many factors degrade the performance of  $\text{Nb}_3\text{Sn}$  strands:
  - Plastic deformation during cabling
  - Lorentz force during operation at high field
  - Precompression during magnet fabrication
- In this study, the impact of cabling deformation on  $\text{Nb}_3\text{Sn}$  strand microstructure and properties under controlled conditions has been simulated using rolling (performed at Fermilab).

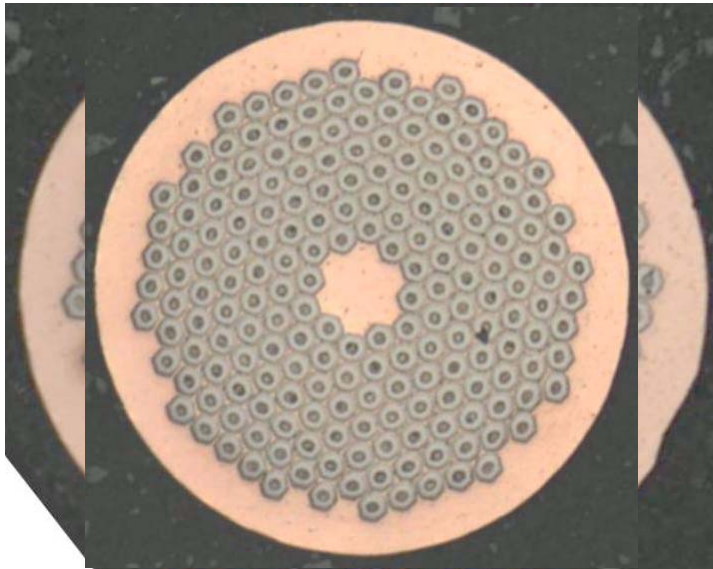
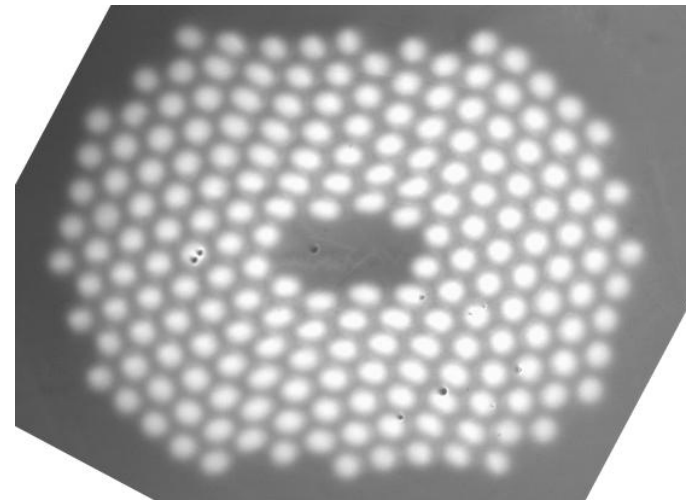
# PIT ROLLED TO 0.8 mm : OPTICAL AND MO IMAGES at T=12K, H=0

No damage to filament integrity observed by microscopy filament

MO shows no significant variation in properties from filament to filament

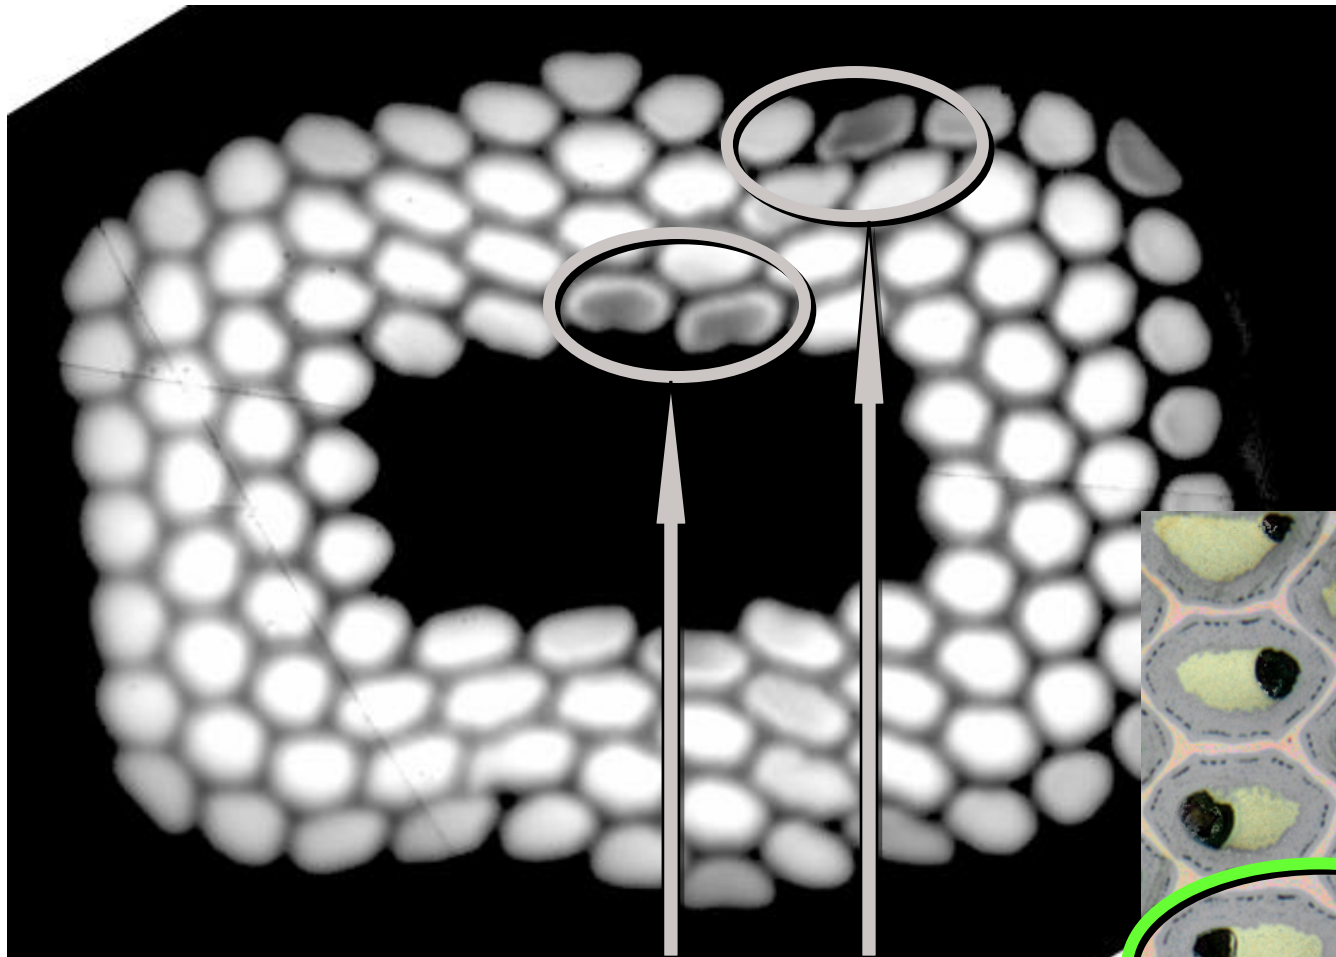
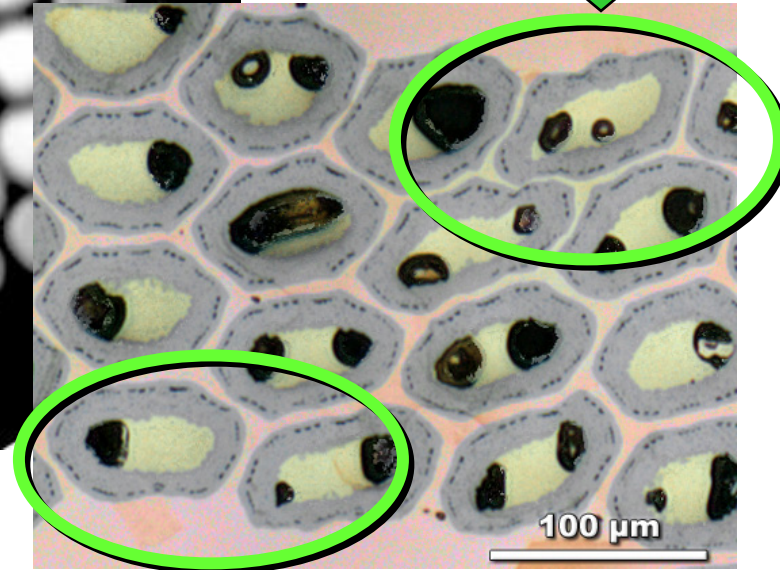
# IT RRP Rolled to 0.8 mm: MO T=12 K, H=0

LSCM+color  
image shows Sn  
leakage between  
outer sub-  
elements only

*MO shows damage to both  
outer and inner sub-elements*

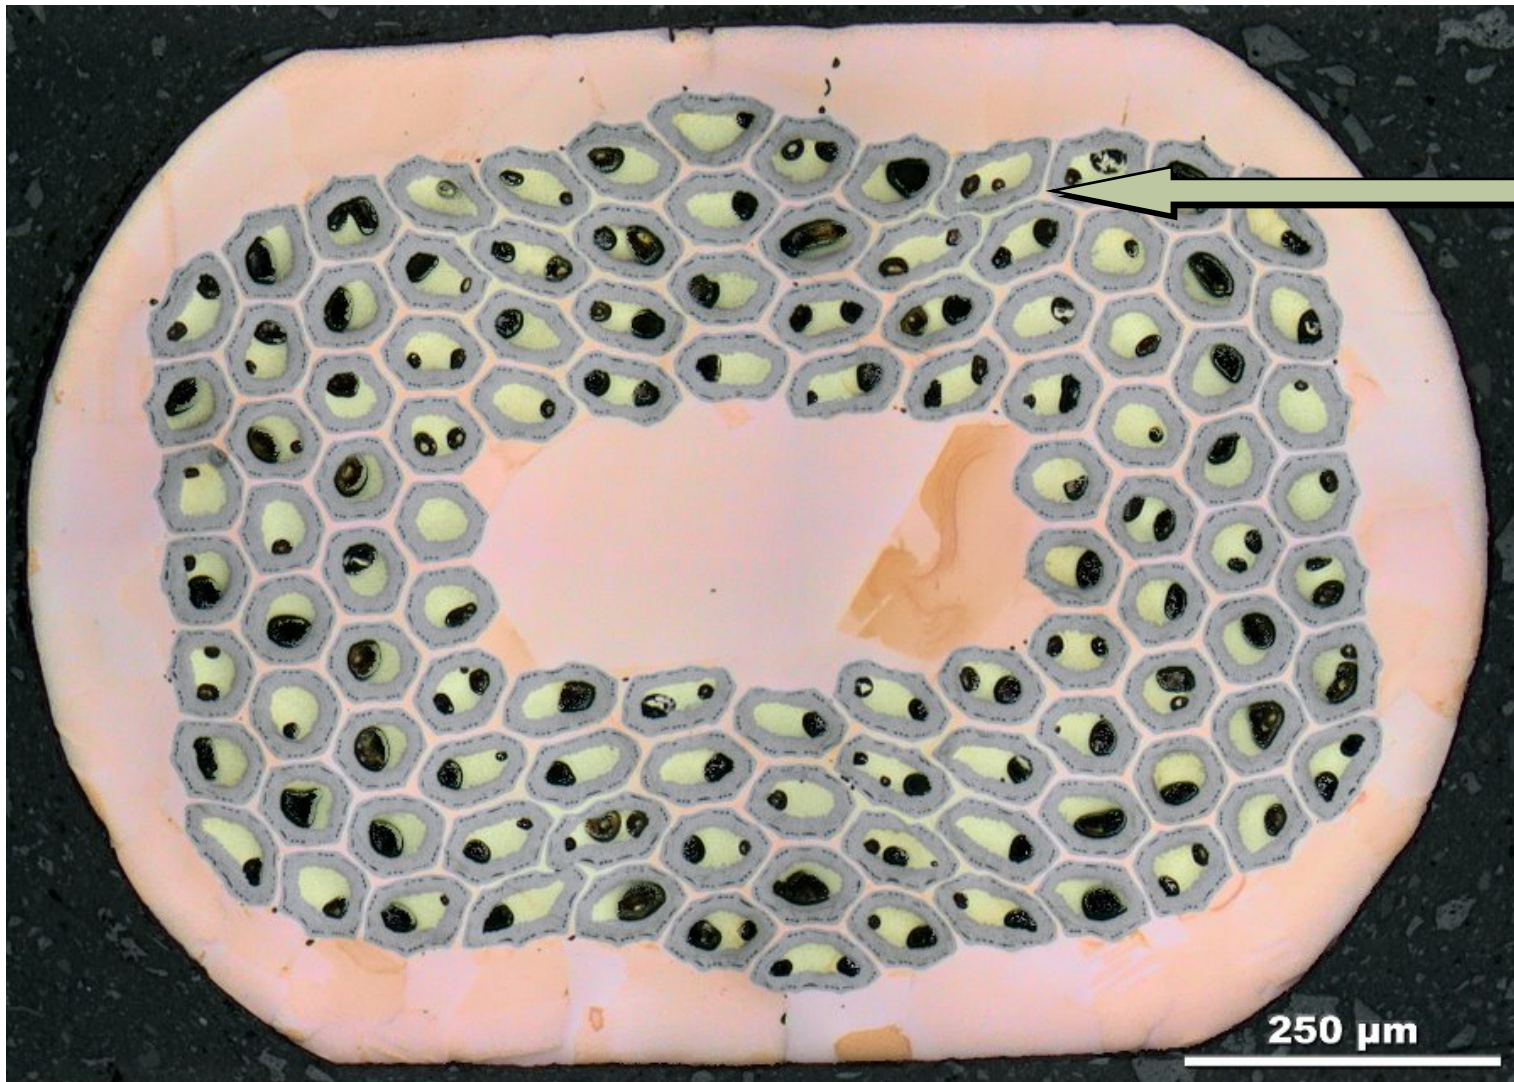
# IT RRP Rolled to 0.8 mm : Cross-Section

Sub-elements not broken but some Sn leakage observed by color contrast

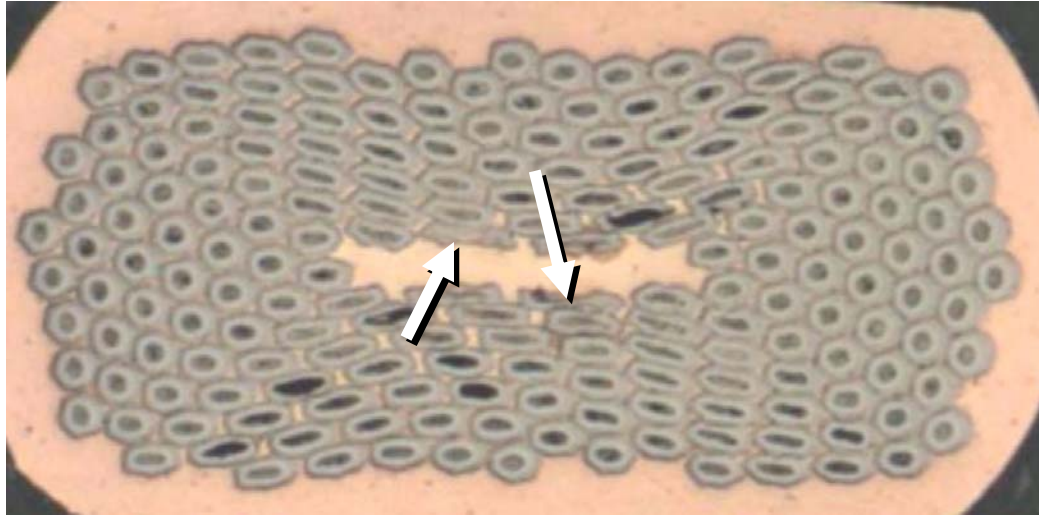
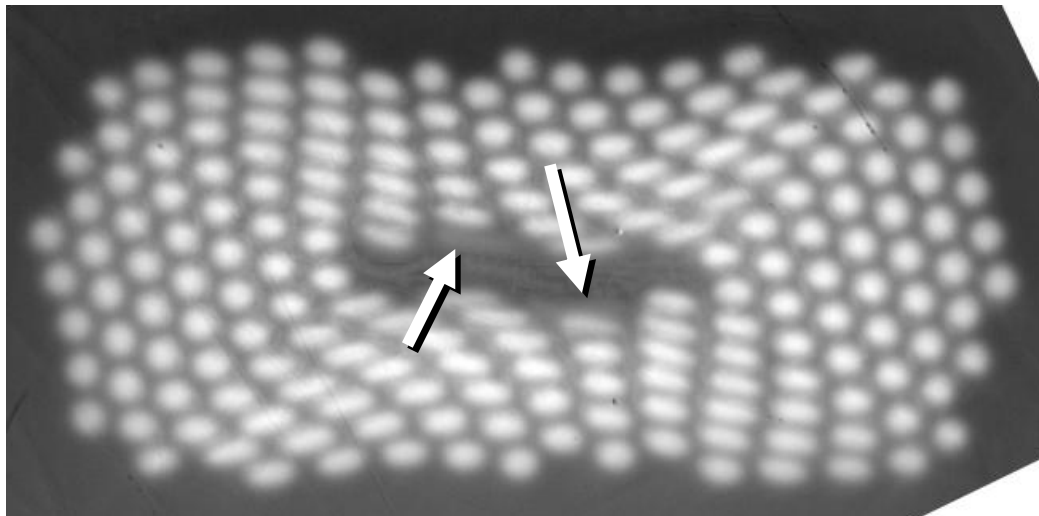
# PIT Rolled to 0.6 mm: Color & MO: T=12 K, H=0

Only a few central filaments have been broken by the rolling.

*But* all the superconductivity in those filaments is lost at 12 K

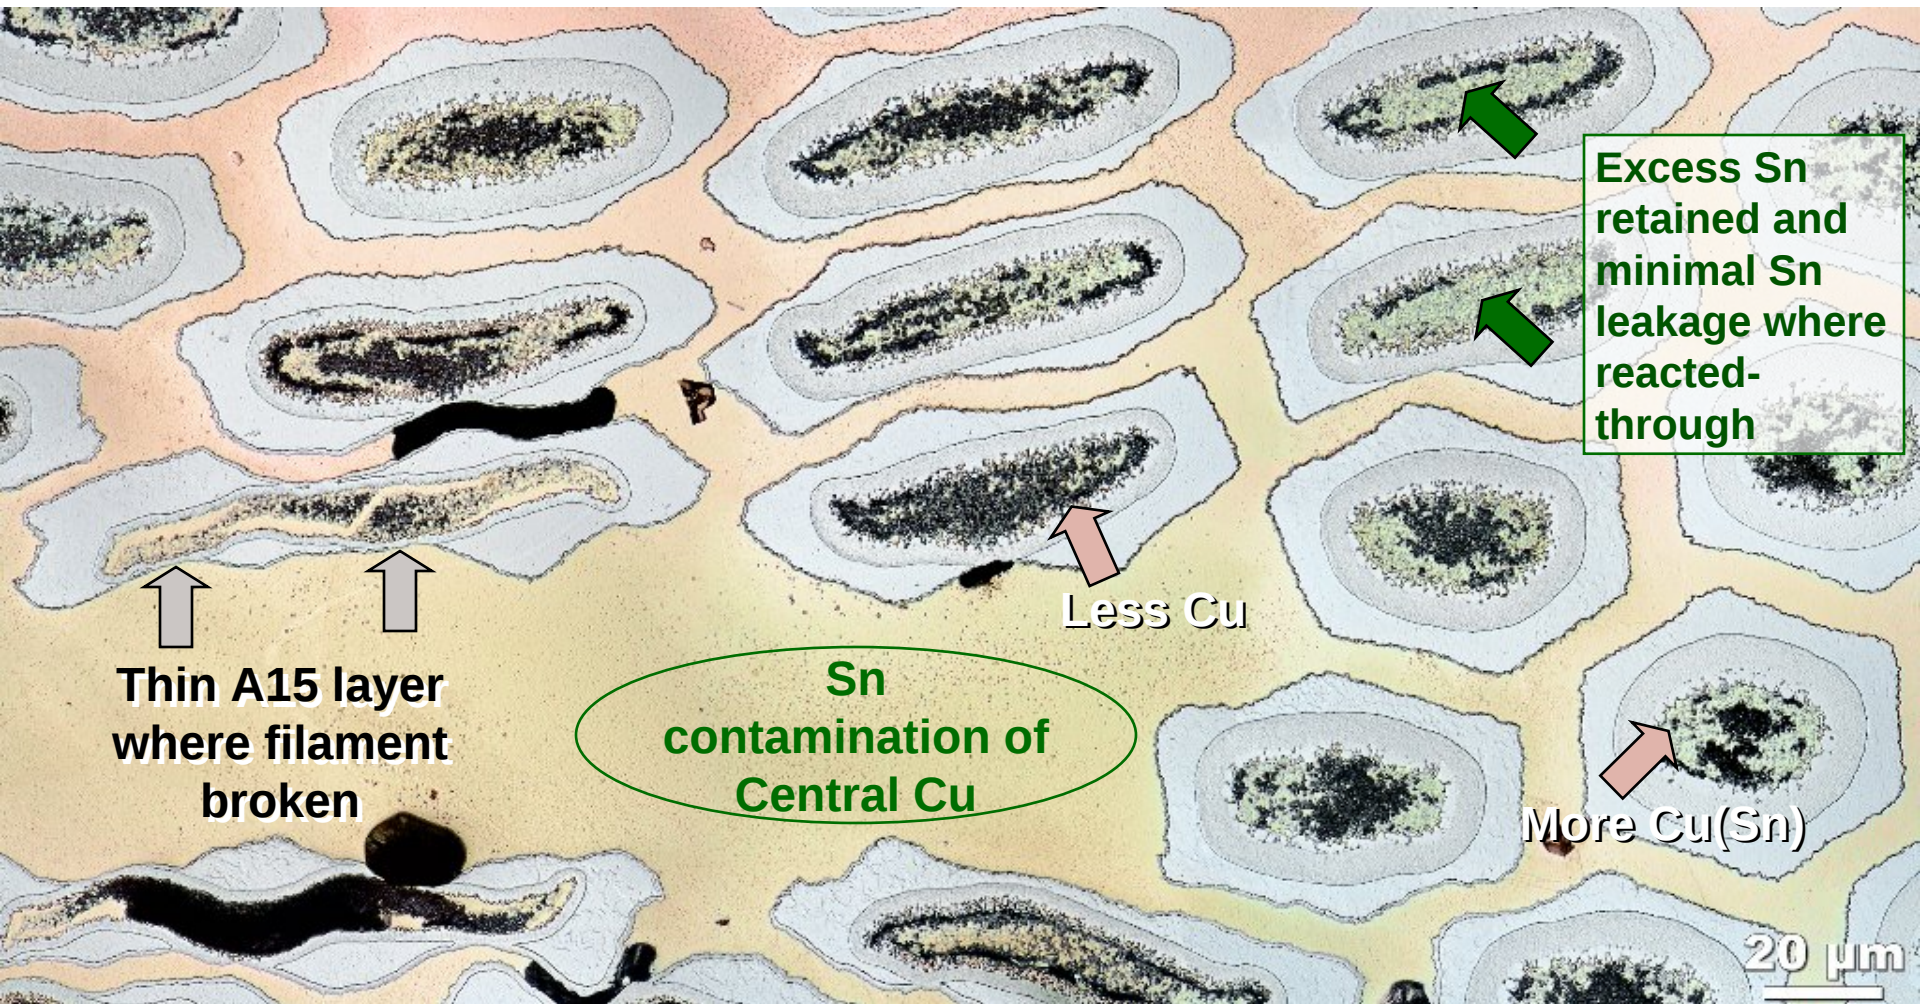
# When PIT filaments break . . .

LSCM+color enhanced to shows Sn leakage

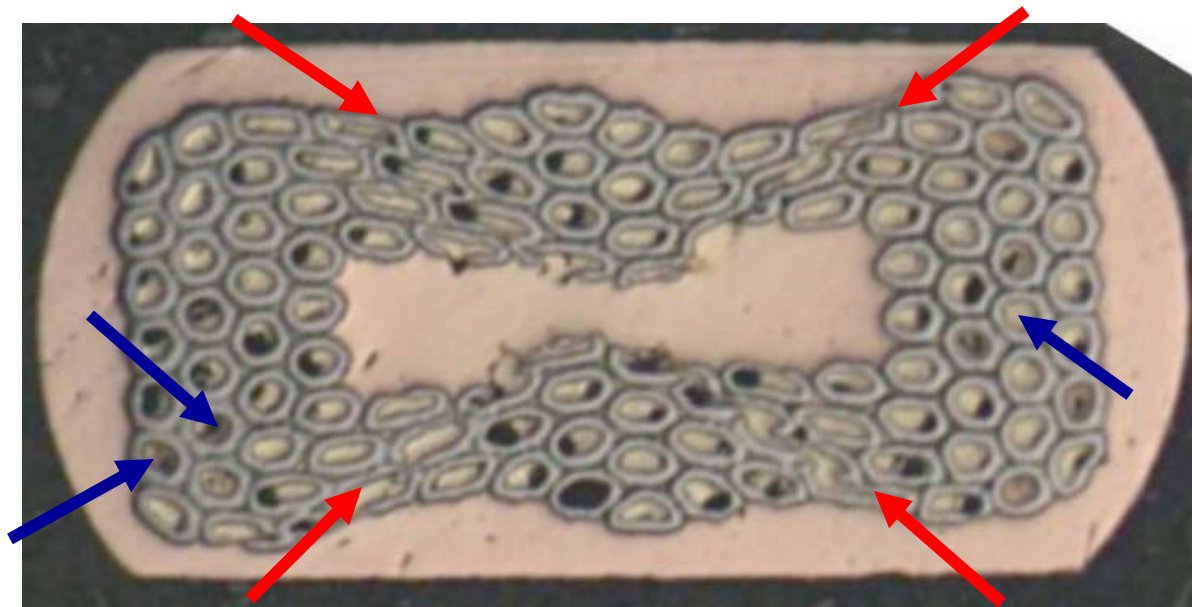
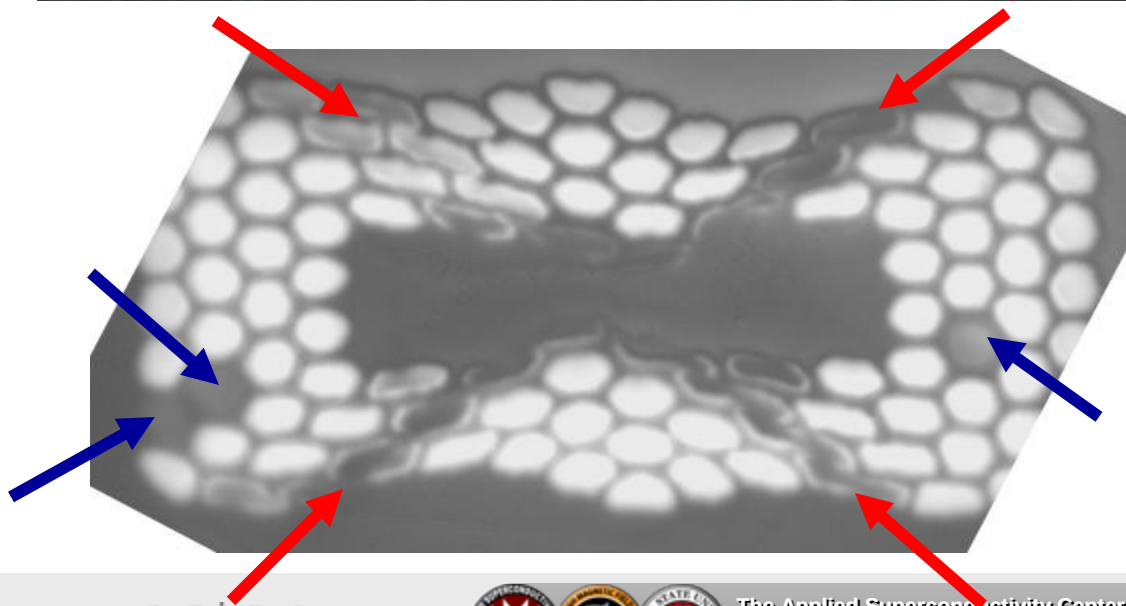
# RRP Rolled to 0.6 mm: Color & MO: T=12 K, H=0

**Broken  
subelements  
along shear  
planes**

**Low  $T_c$   
subelements  
with partially  
reacted Nb (Sn  
loss from sub-  
elements)**

**MO shows two  
types of defects  
in RRP1**

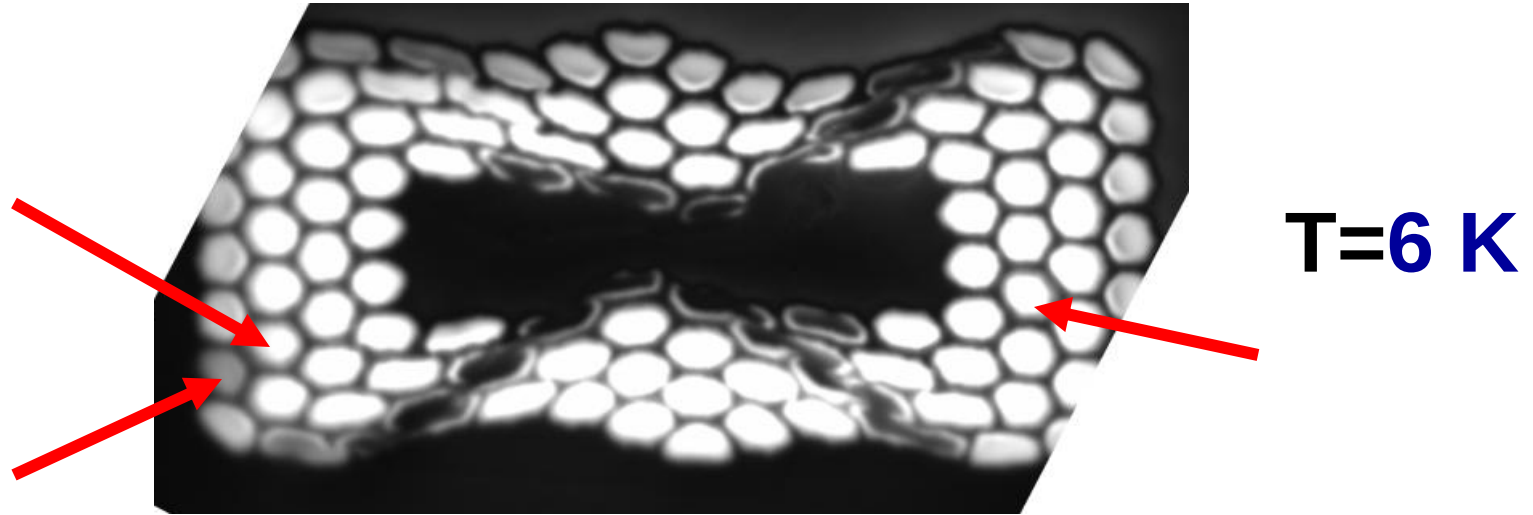
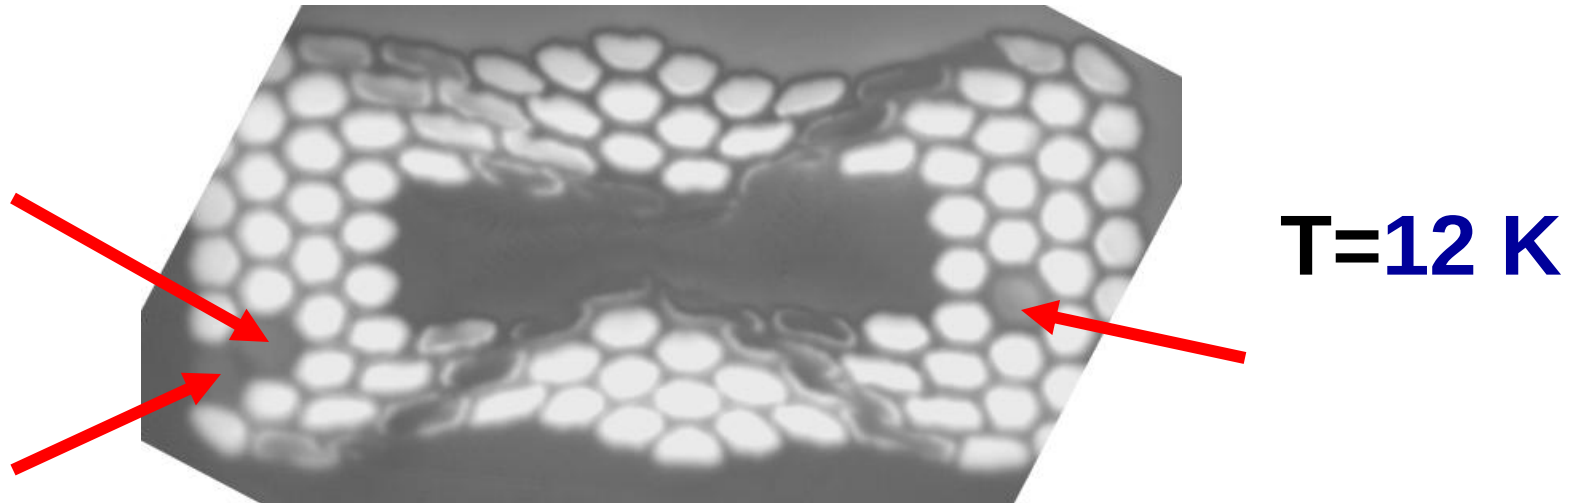
# MO Shows $T_c$ Reduction in Sub-Elements that are **Not** Damaged in this Cross-Section

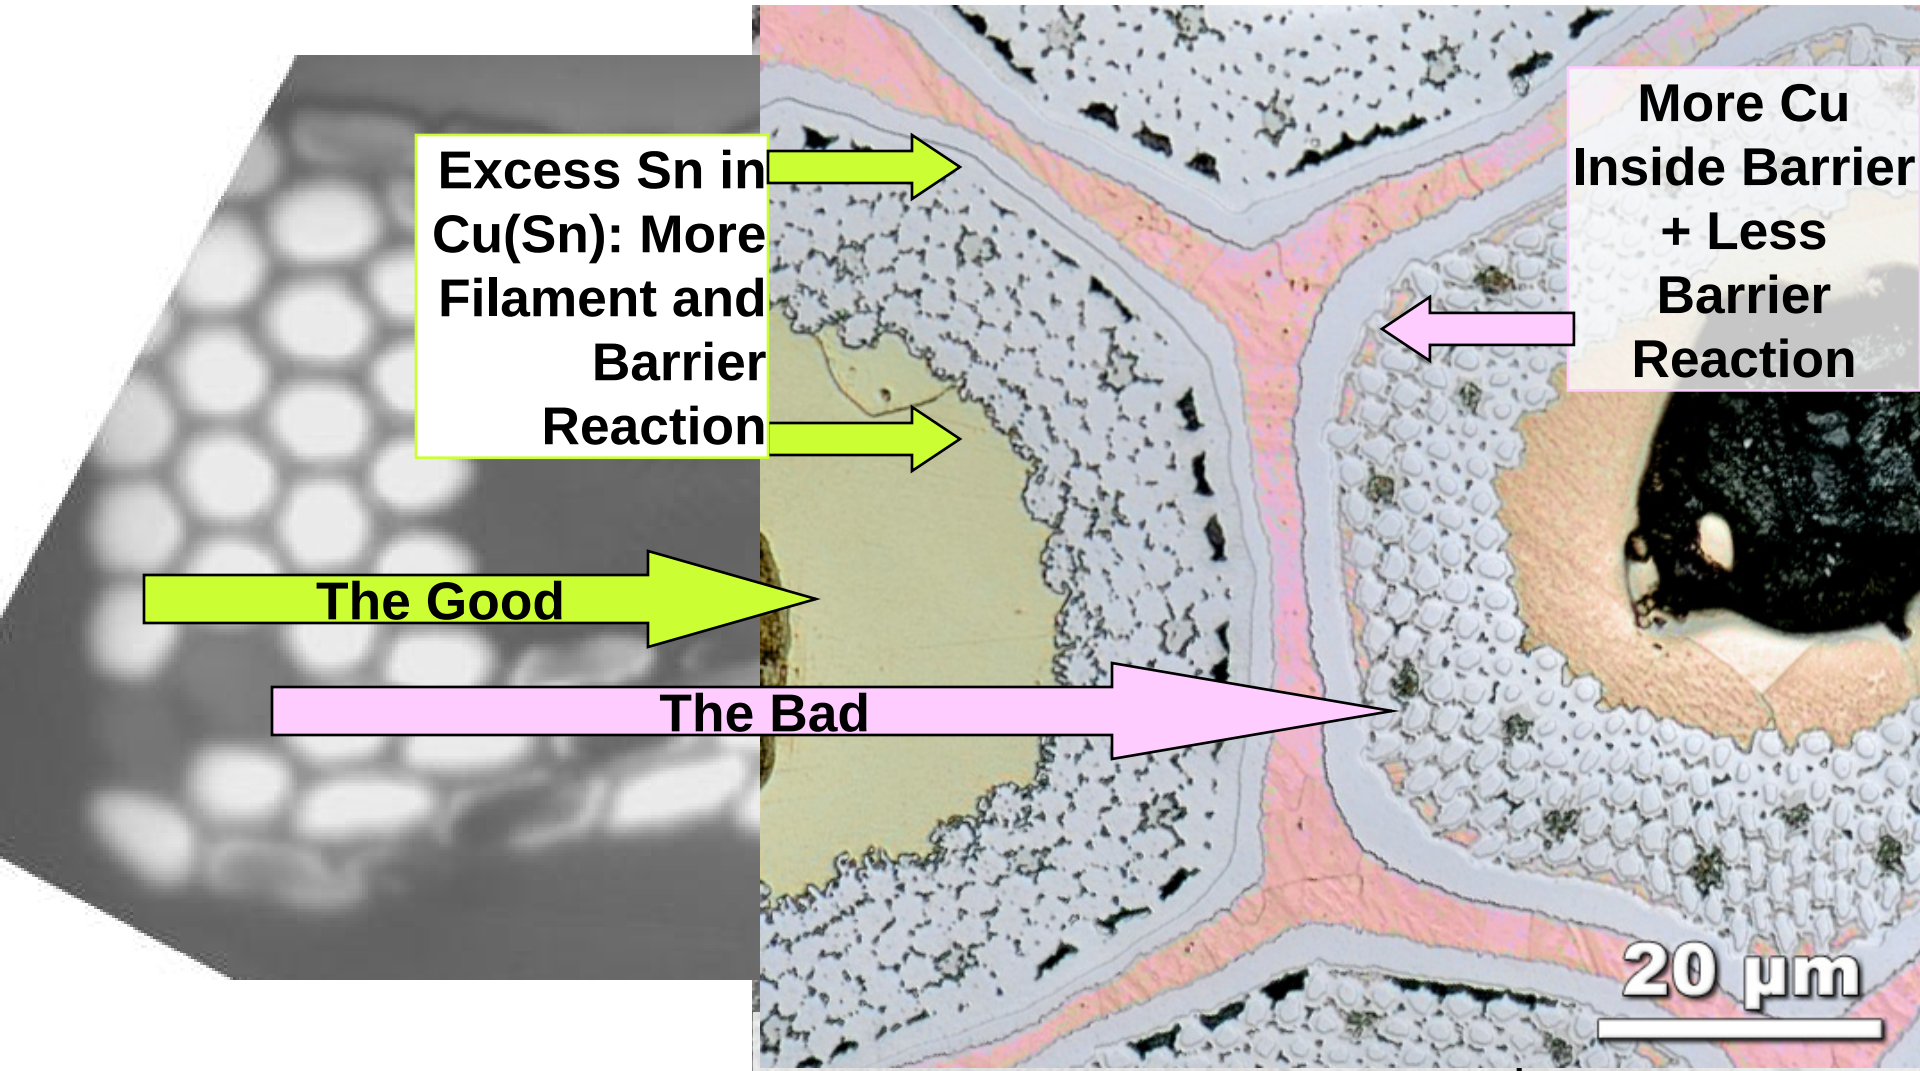
# Unreacted Nb Filament Cores In Low $T_c$ Sub-Elements

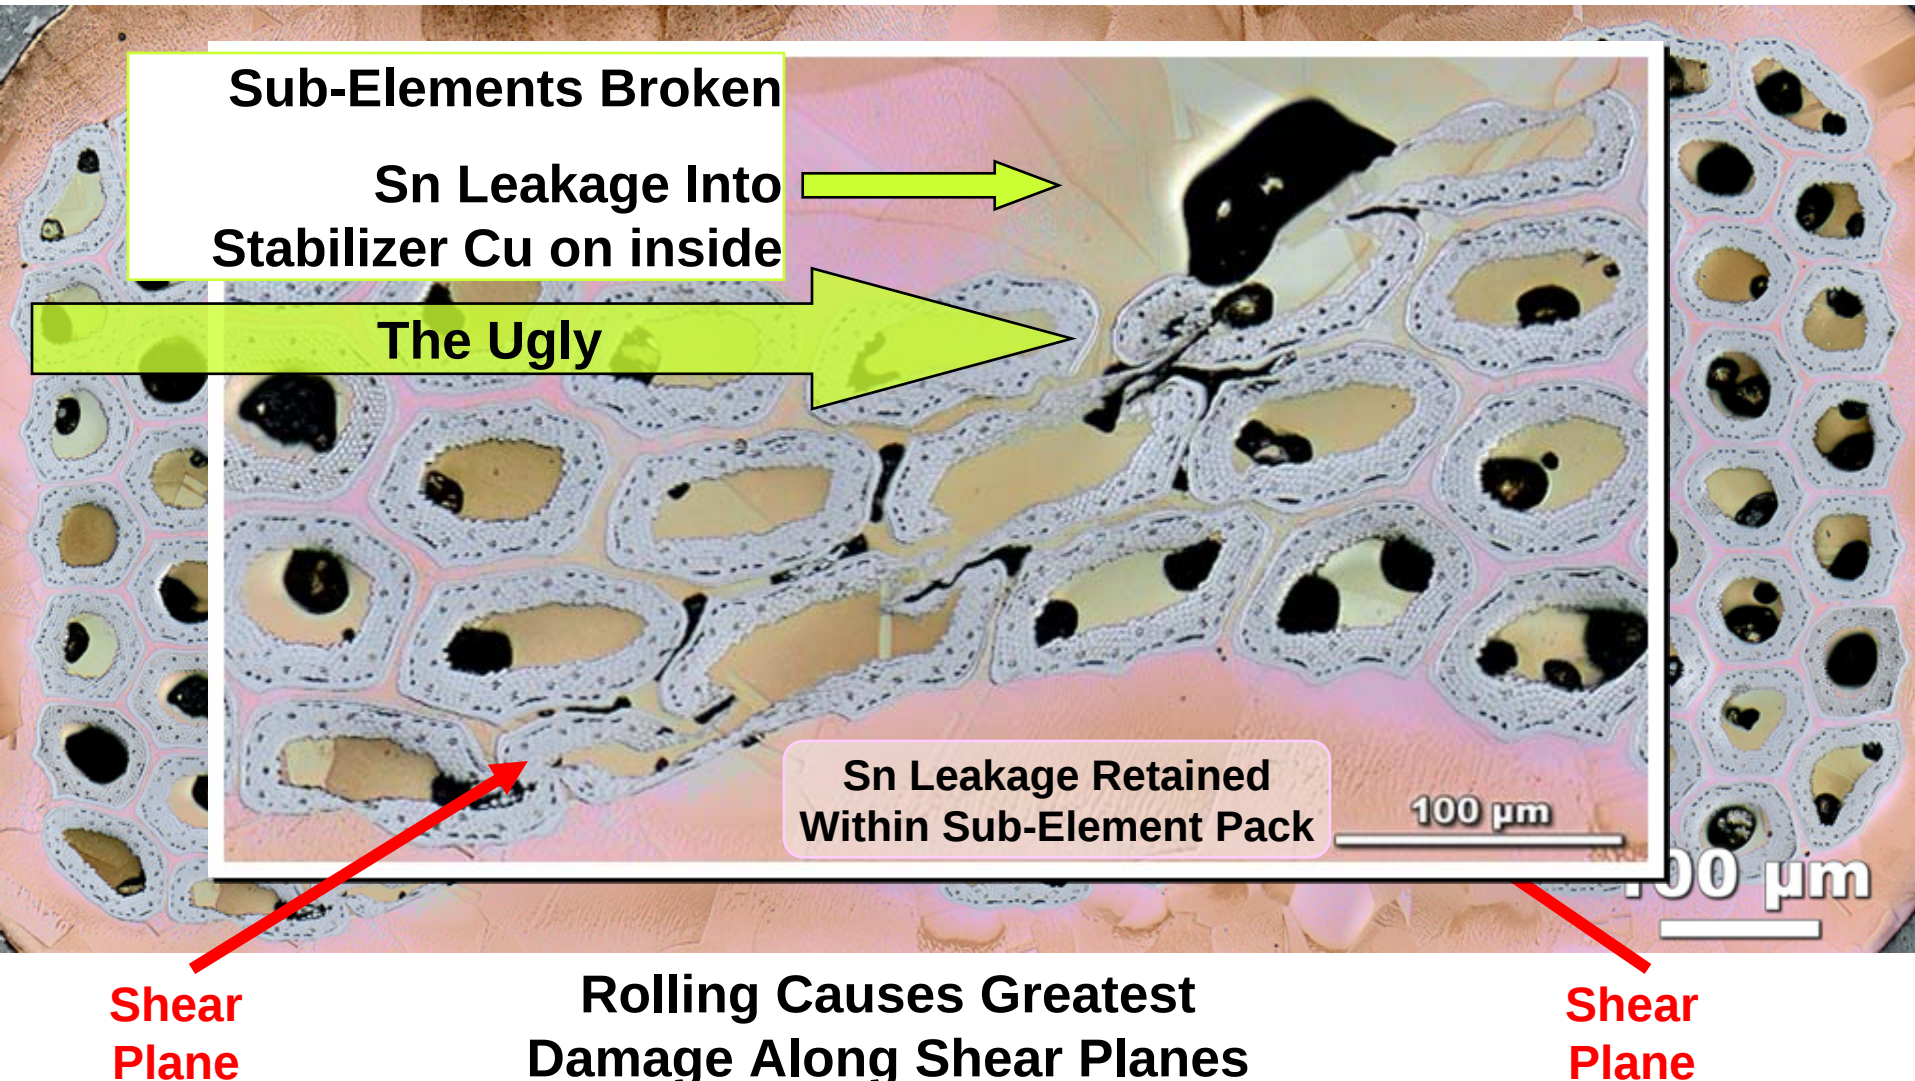
# Broken Sub-Elements In Shear Planes

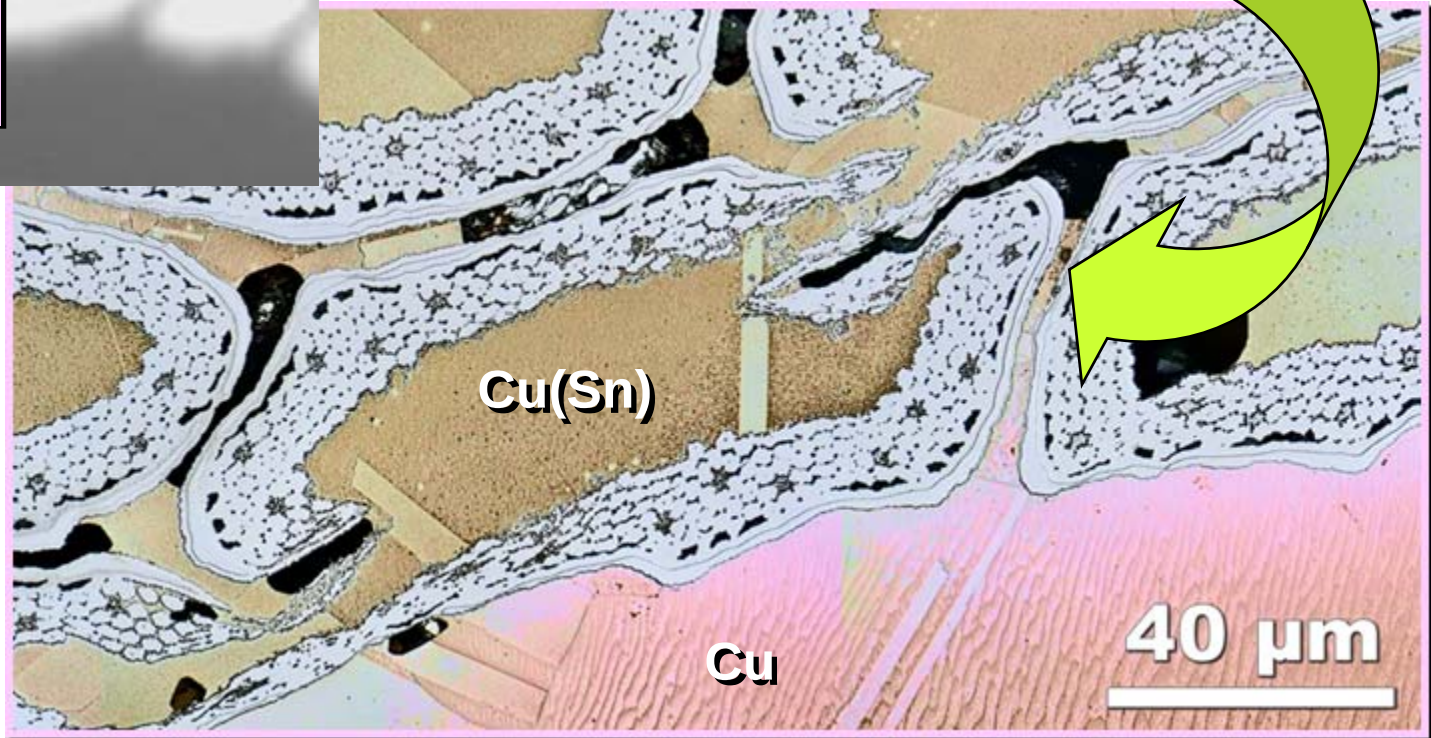
# Sn Retained In Sub-Element Pack

Restriction in Cu between sub-elements reduces Sn loss into outer Cu

Sufficient excess Sn retained to maintain superconductivity at 12 K

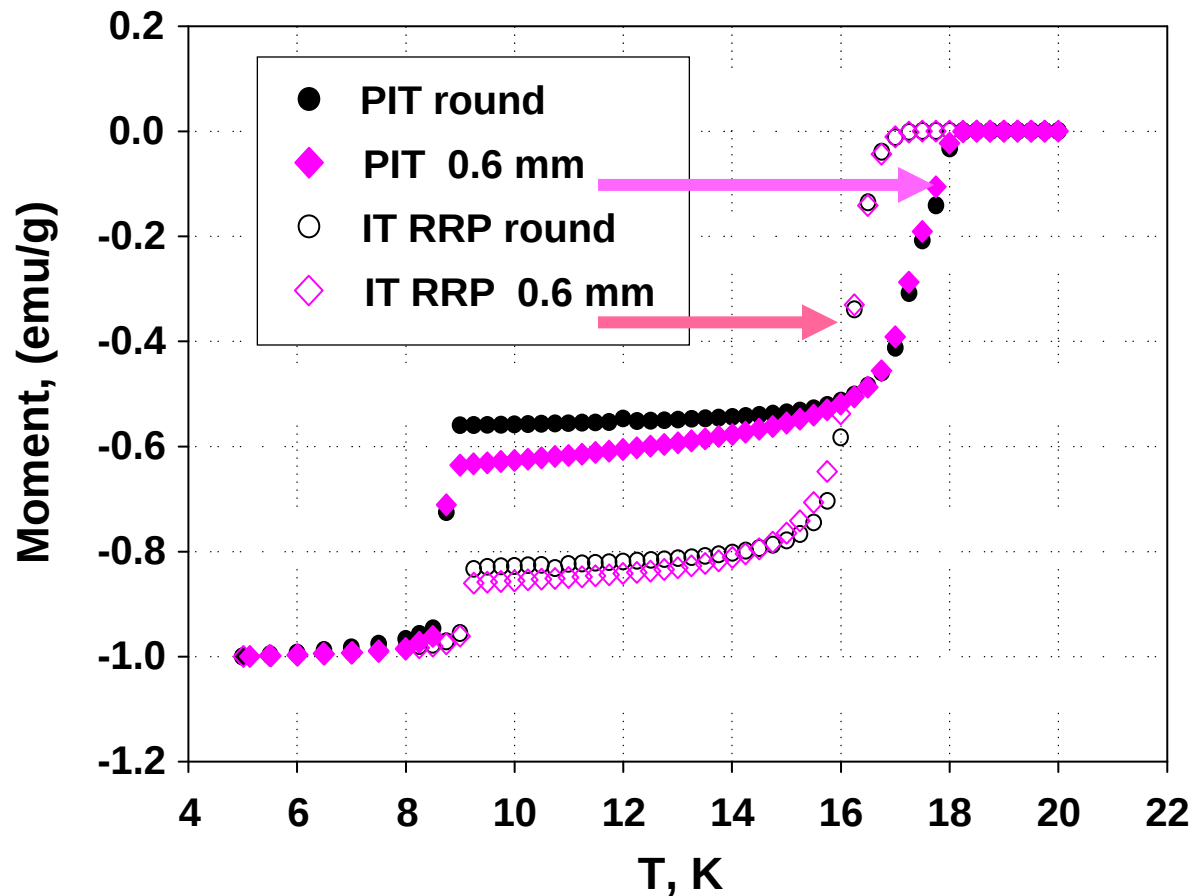
# $T_c$ Dependence vs. Rolling Deformation

The IT RRP strand uses Ti doping (from Nb-Ti rods) to enhance high field  $J_c$  and consequently has a lower  $T_c$  than the Nb(Ta)<sub>3</sub>Sn of the PIT strand.

Deformation of the strands produces some broadening at the low end of the A15 transition due to lower-Sn A15 being formed.

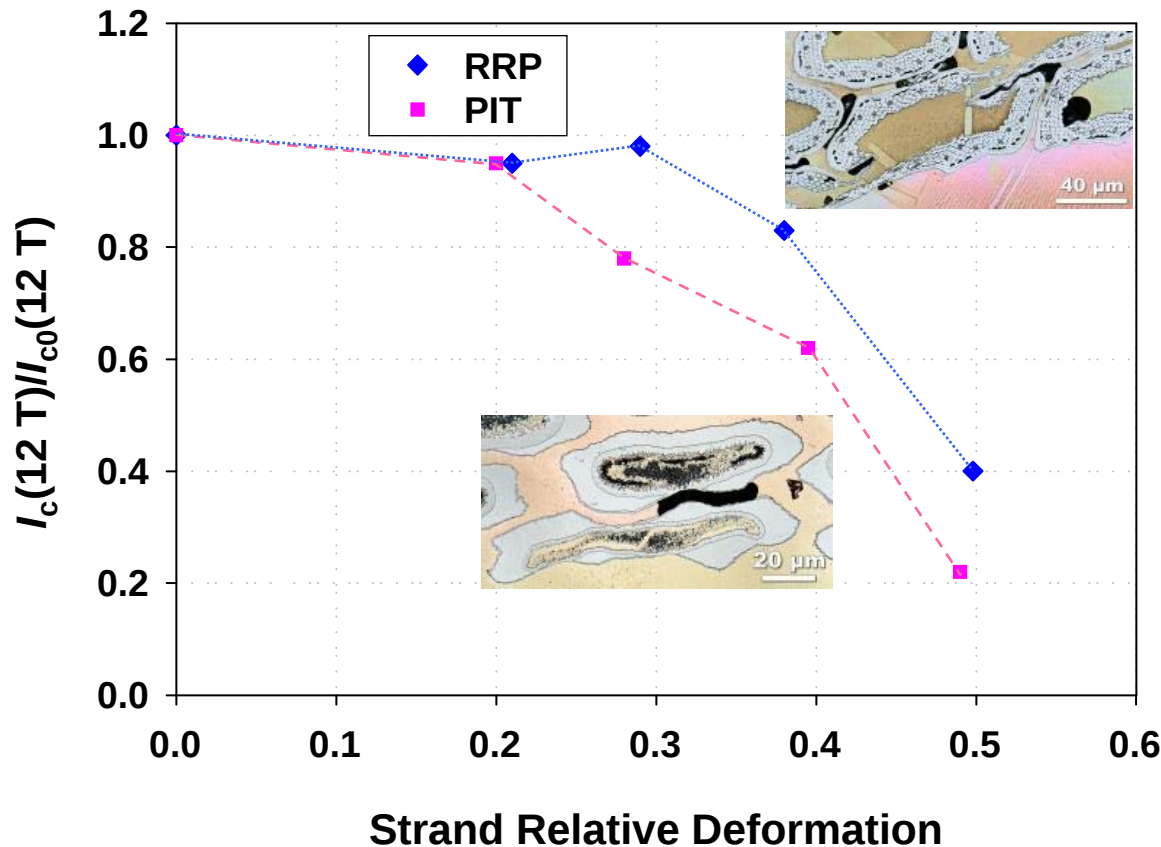
# Transport $I_c$ Dependence at 12 T (4.2 K)

- Both Strand Designs maintain  $J_c$  out to 80% of original diameter.
- PIT  $I_c$  drops faster after that perhaps because the short HT used for PIT strands (47-64 hr) means that loss of the high Sn is more catastrophic to A15 volume.

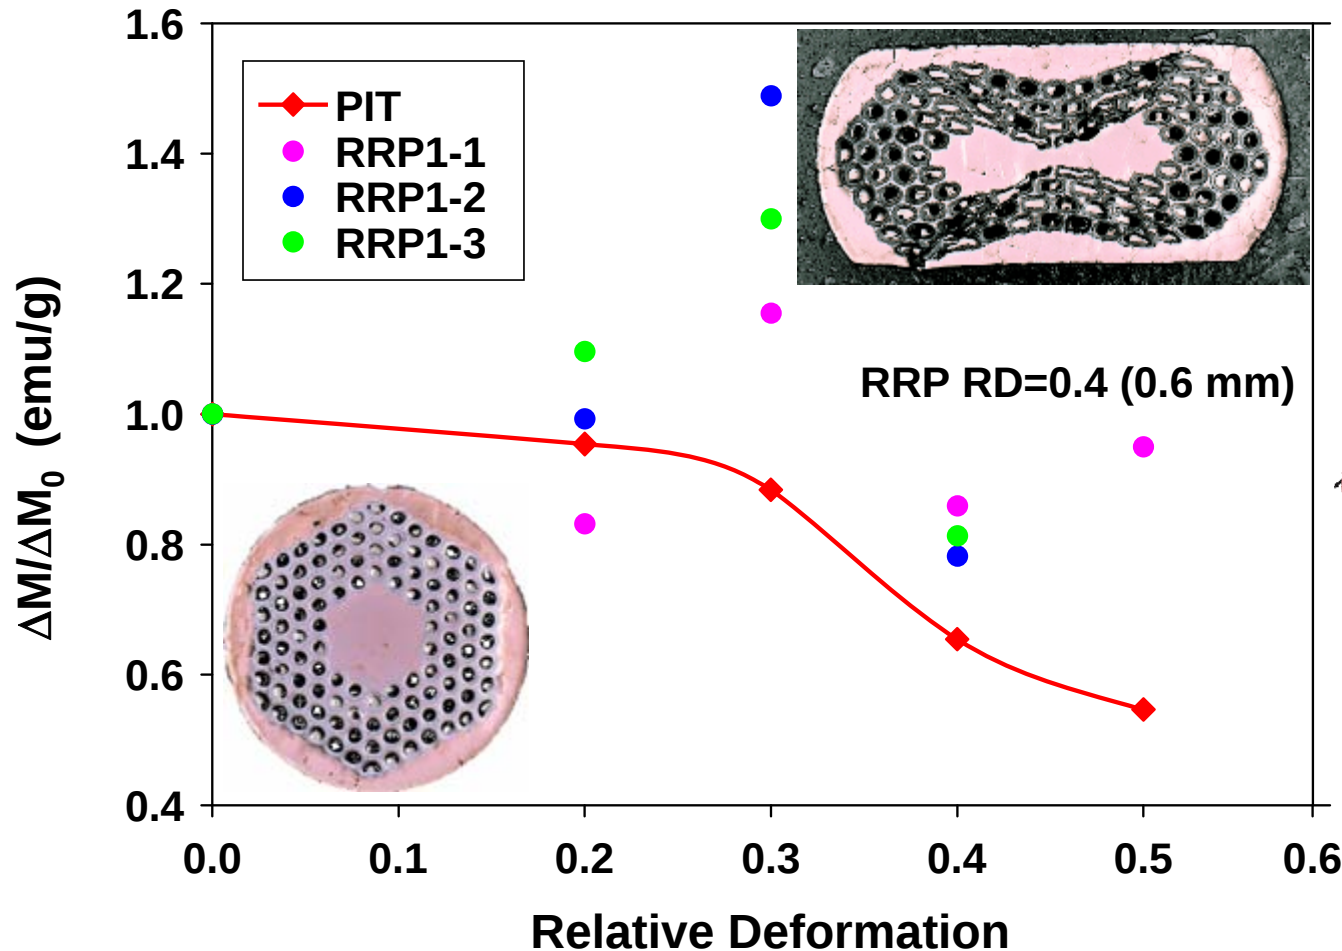
# Magnetic Moment at T=12 K and H=2 T

12 mm twist pitch applies different geometric distortions

Magnetization measurements show considerable scatter in measurements for the deformed RRP strands
